**Oak Tree Report**  
**for the**  
**Estrella River Vineyard**  
**Tract 2905**

Estrella Road  
Paso Robles  
San Luis Obispo County

**April 2008**

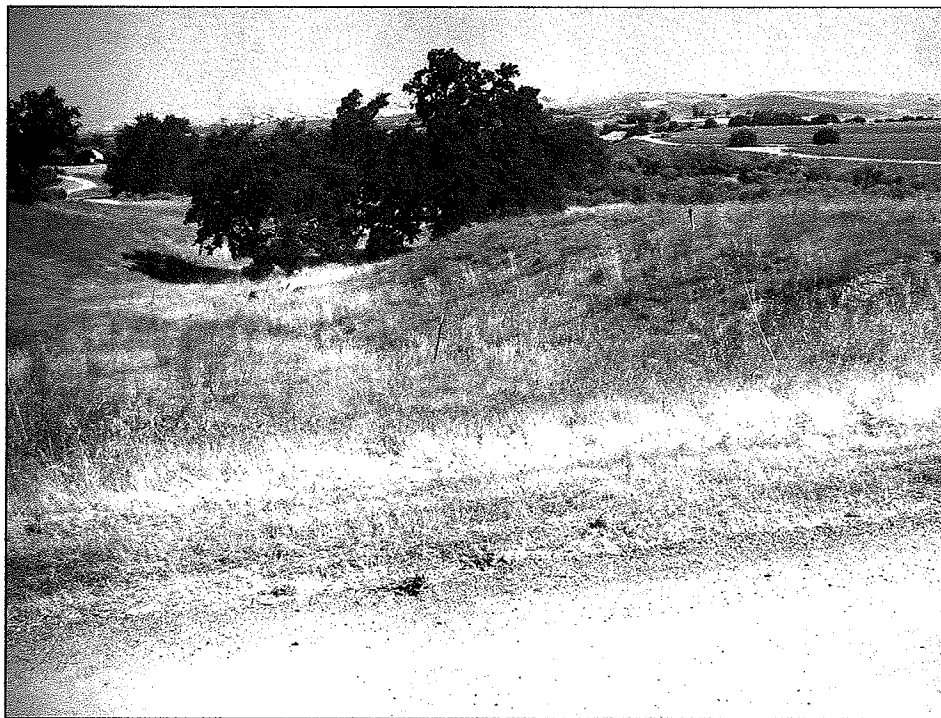
Photo 8. View northwest of the proposed oak tree mitigation area. The mitigation area is a grassy swale close to the northern reservoir where irrigation water would be available.
